Manhole Inspection Summary

Manhole # S49Y1_001MH

Insp Date: **10/22/08 5:19 PM**

Location Address: **1628 Chesapeake Ave.**

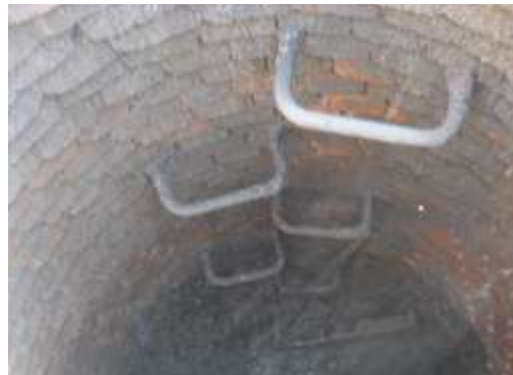
Steps

Count: **5** Missing: **0** ☐ Corroded

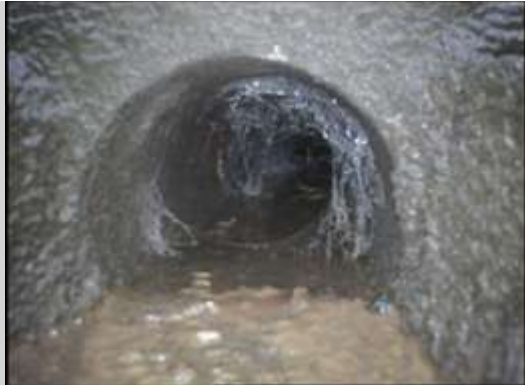
12 O'Clock Outflow

8 in. Circular Gravity Sewer
Pipe Out @ 12 O'Clock

Pipe Height: **9.6** (in.) Rod and Bar (Angled)
Pipe Material: **Clay** ☐ Pipe Lined
Invert Depth: **10.45** (ft.) Flow Characteristics: **Slow**
Deposits: ☐ None ☒ **Mud** ☐ Sludge ☐ Debris ☐ Grease
Silt Depth: **5** (in.) Deposits Extent: **Heavy**
Infiltration: **None** Pipe Seal Cond: **Sound**

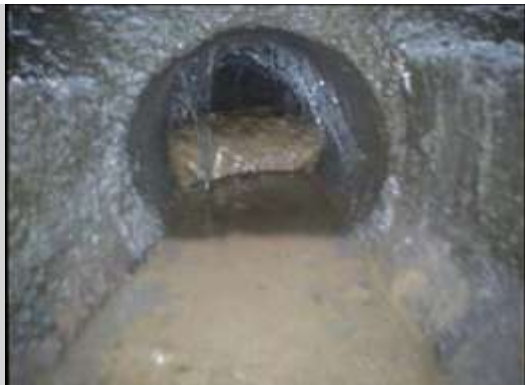
3 O'Clock Inflow

8 in. Circular Gravity Sewer
Pipe In @ 3 O'Clock

Pipe Height: **9.6** (in.) Rod and Bar (Angled)
Pipe Material: **Clay** ☐ Pipe Lined
Invert Depth: **10.30** (ft.) Flow Characteristics: **Slow**
Deposits: ☐ None ☒ **Mud** ☐ Sludge ☐ Debris ☐ Grease
Silt Depth: **5** (in.) Deposits Extent: **Heavy**
Infiltration: **None** Pipe Seal Cond: **Sound**

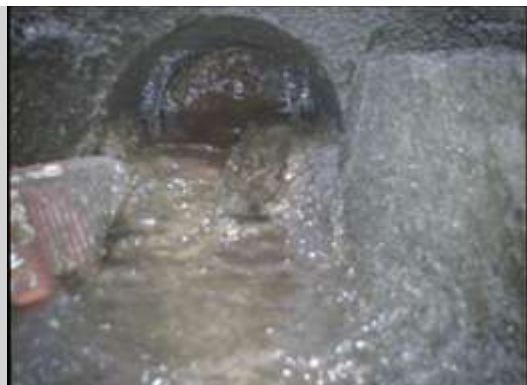
9 O'Clock Inflow

8 in. Circular Gravity Sewer
Pipe In @ 9 O'Clock

Pipe Height: **8.4** (in.) Rod and Bar (Angled)

Deposits: ☐ None ☒ **Mud** ☐ Sludge ☐ Debris ☐ Grease

Silt Depth: **6** (in.) Deposits Extent: **Heavy**
